TECHNICAL BULLETIN

LTB00585
22 AUG 2013

Difficulty In Selecting Gears/Poor Gear Shift Quality

Defender (LD)

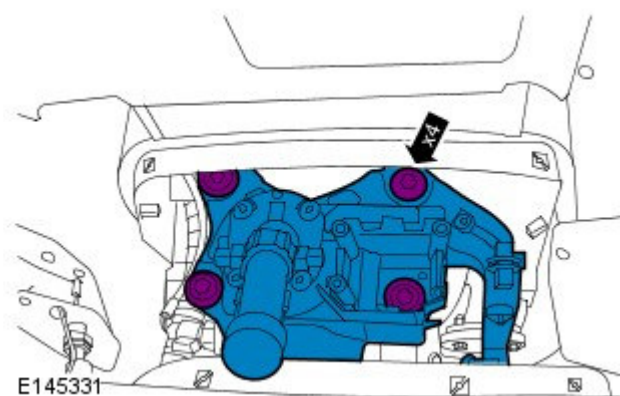
Situation: A customer may report difficulty in selecting gears/poor gear shift quality due to the gear mechanism assembly moving.

Cause: Shifter bush clearance hole dimensions to large.

1. Remove the Transfer Case High/Low Range Linkage follow steps 1 to 13 (see TOPIx Workshop Manual, section 308-07).
2. Loosen the gearshift lever securing bolts as shown in the illustration (E145331).
