TECHNICAL BULLETIN
LTB00477v2
20 AUG 2012

SECTION: 308-01

Clutch Noise

Defender (LD)

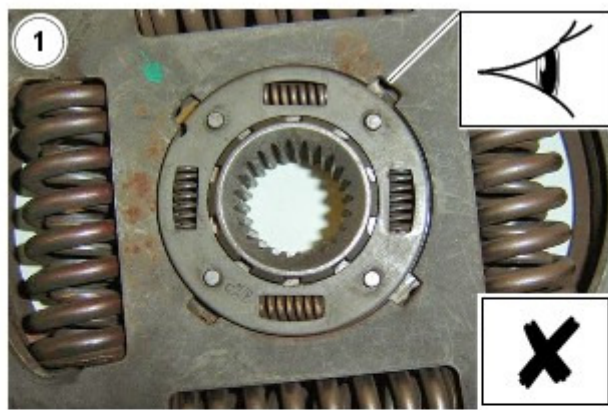
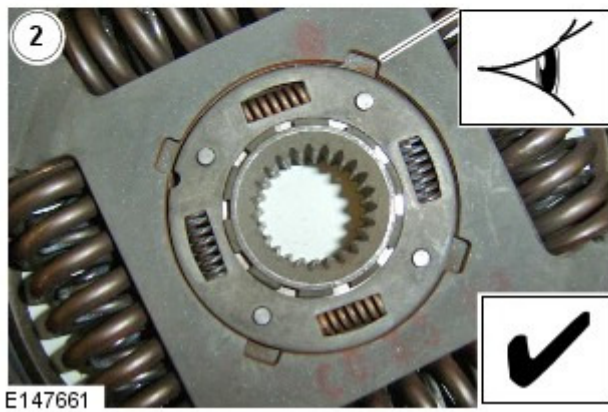
Cause: The thrust washer fitted around the centre hub of the clutch disc may have sheared (this does not cause operation failure of the clutch it generates an audible noise only). **Suggested Customer Concern Code - P24.**

1. Remove the clutch disc and pressure plate (see TOPIx Workshop Manual, section 308-01).
2. Inspect the clutch disc for signs of damage to the thrust washer.

1. Damaged or missing thrust washer.
2. Correctly located thrust washer.

Install the new design clutch disc and pressure plate (see TOPIx Workshop Manual, section 308-01).

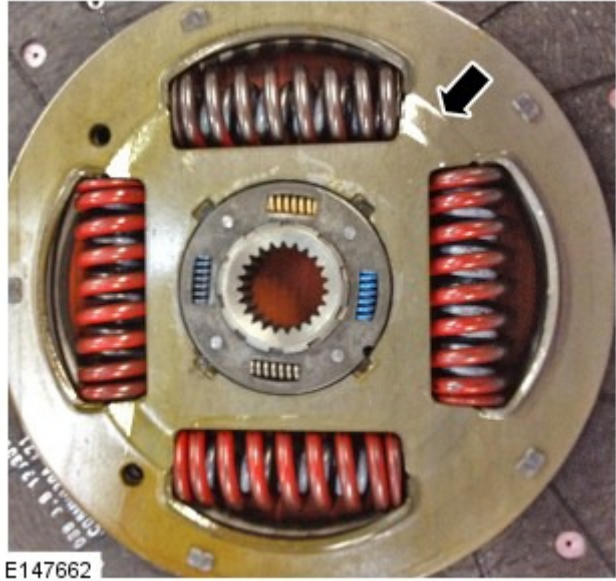
NOTE: The new design clutch disc has a gloss finish and a bonded thrust washer.
