TECHNICAL BULLETIN

LTB00406v3

Heating Ventilation Air Conditioning Evaporator (HVAC) Temperature Reading Inaccurate - Evaporator Freezes

Defender (LD)

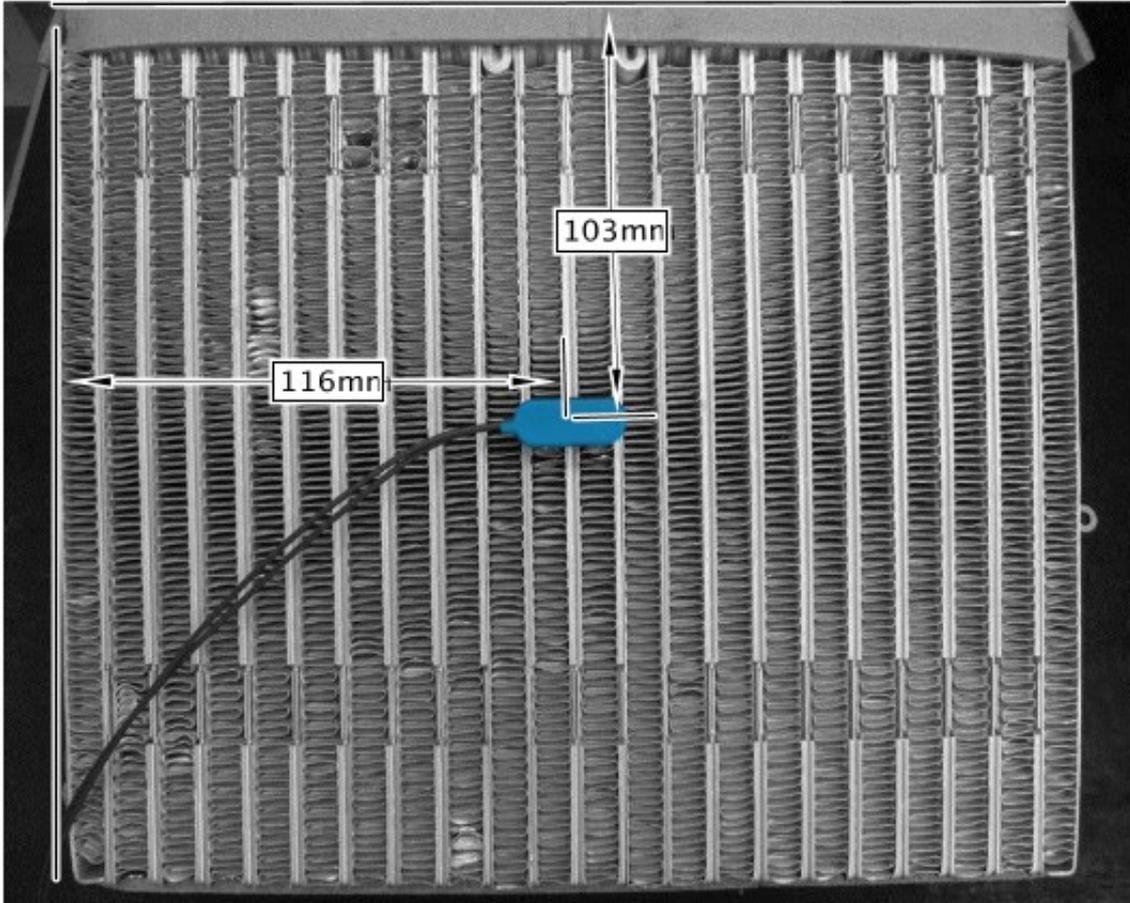
NOTE: Only an evaporator temperature sensor with a white identification sticker must be used, they will also have the number 1398 -900 -03E printed on them. Sensors with either green or yellow stickers on

them must not be used.

**NOTE: See graphic E170769 for the new type of the HVAC evaporator temperature sensor and the correct position for it to be fitted.**

Install a new HVAC evaporator temperature sensor.
