Attachment 1

Engine cranking non start with instrument pack temperature gauge in the red.

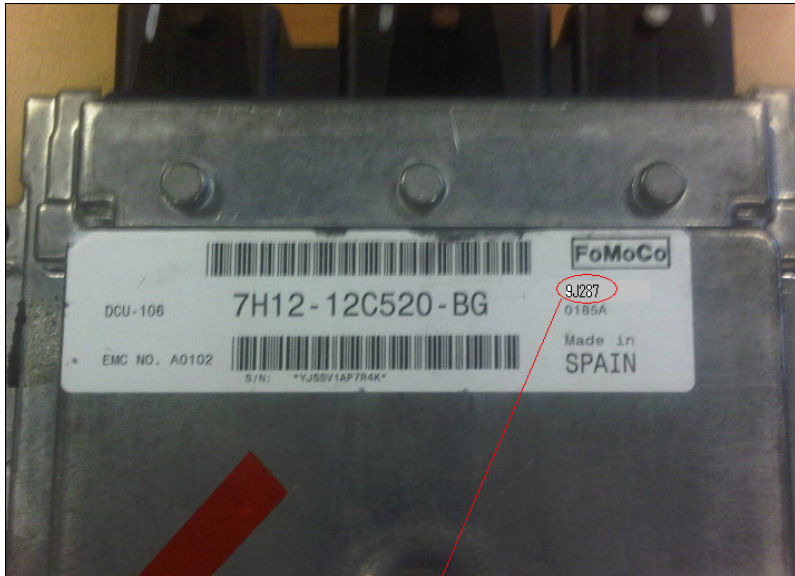
Example Date Code

5. Remove the PCM module cover and with reference to photograph below, note the date code reference number and identify the build date of the PCM. If the build date is earlier than the 14th October 2009, replace the PCM with reference to GTR 18.30.03 and re-assess the vehicle, if the concern no longer appears and no further fault codes are stored in the PCM return the vehicle to the customer.

9J287

Note: Please do not replace the PCM where the date code translates to the 14th October 2009 onwards.

If the concern re-appears or the PCM has a build date of 14th October 2009 onwards, please submit a Technical Request for further advice.
