TECHNICAL BULLETIN LTB00467 18 JUN 2012

SECTION: 417-00

Defender Headlamp Switch Overlay Kit

Defender (LD) Model Year: 2007-2011

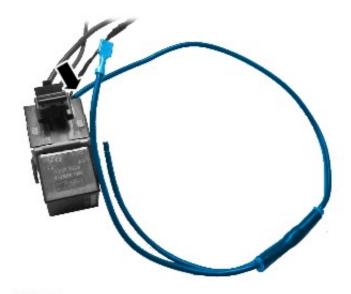
E143657

Install brown/blue wire (NU) to the empty pin 3.

• Remove and discard blue wire (no connector) from relay pin 3.

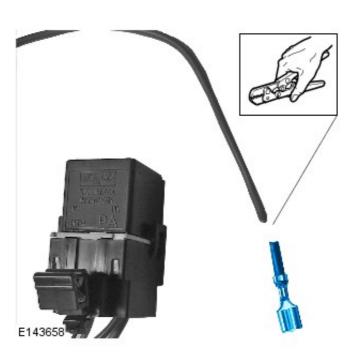
7. Cut the spade end connector off the end of the wire in pin 2.

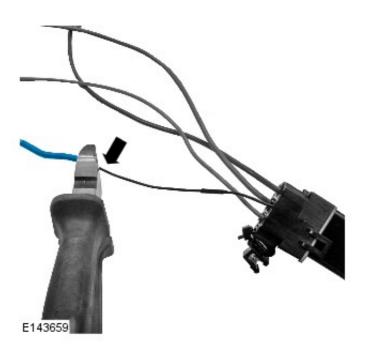
8. Cut the ground wire before the splice

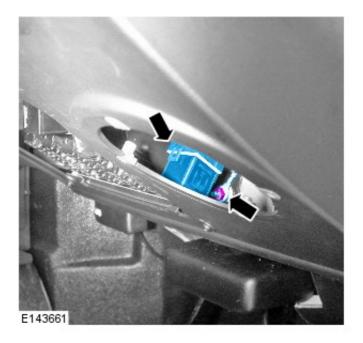
- **10.** Install the relay to the vehicle.
 - RHD vehicles Secure the relay in position with the clip.
 - LHD vehicles Secure the relay to the fusebox bracket using suitable tie straps.
 - Connect the ground harness to the vehicle at a suitable ground point.

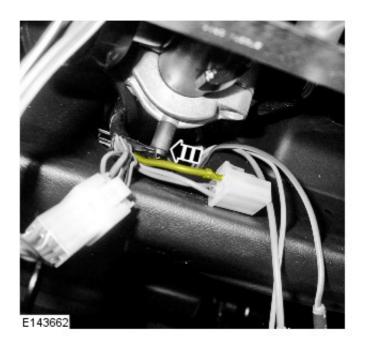
NOTE: RHD - Connector number C0041.

NOTE: LHD - Connector number C1082.

Using a suitable tool, back out pin 1 (brown/blue (NU)) from appropriate connector.

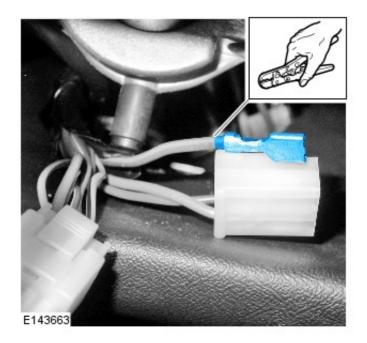
13. Cut-off and discard the spade end connector from the backed out wire.

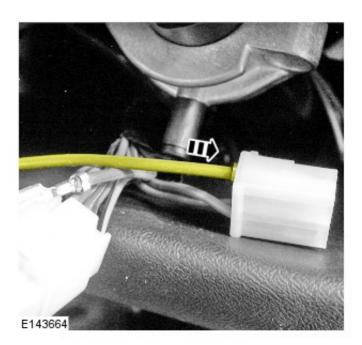
14. NOTE: RHD - Connector number C0041.

NOTE: LHD - Connector number C1082.

Install the brown/blue (NU) connector to pin 1 from the appropriate connector.

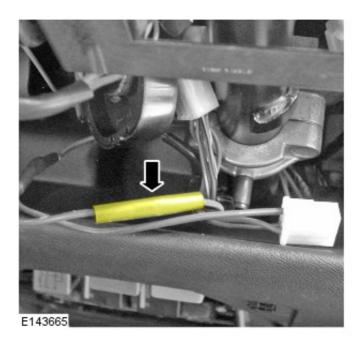
Using suitable tools splice the backed out brown/blue (NU) to the new brown/blue (NU) wire.

- Remove a suitable amount of insulation from both ends of the wire.
- Install suitable heat-shrink and a connector.
- Using a suitable tool, crimp the connector.
- Using a suitable heat gun, secure the heatshrink over the splice.

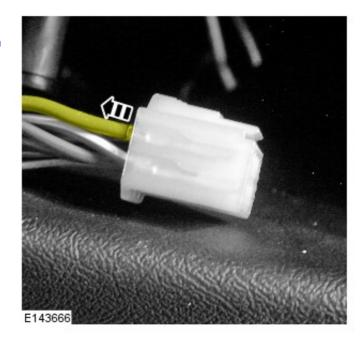
NOTE: RHD - Connector number C1042.

NOTE: LHD - Connector number C1739.

Using a suitable tool, back out pin 1 (blue (U)) from the appropriate connector.

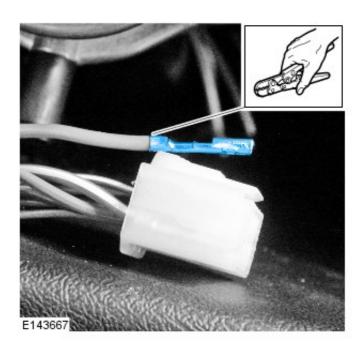
17. Cut-off and discard the spade end connector from the backed out wire.

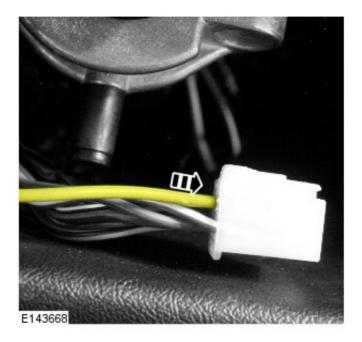
18. NOTE: RHD - Connector number C1042.

NOTE: LHD - Connector number C1739.

Install the blue (U) connector to pin 1 on the appropriate connector.

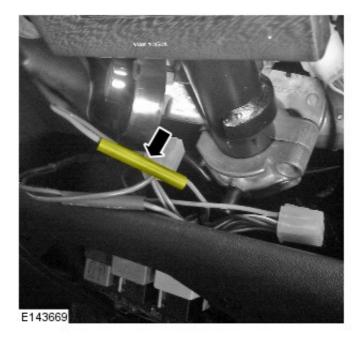
Using suitable tools splice the backed out blue (U) wire to the new blue (U) wire.

- Remove a suitable amount of insulation from both ends of the wire.
- Install suitable heat-shrink and a connector.
- Using a suitable tool, crimp the connector.
- Using a suitable heat gun, secure the heatshrink over the splice.
